# CERCLA Screening Site Inspection Report

**Illinois Environmental  
Protection Agency**  
PO Box 19276  
Springfield, IL 62794-9276

On September 24, 1991 the Illinois Environmental Protection Agency's Pre-remedial Program was tasked by the U S Environmental Protection Agency (U S EPA) to conduct a screening site inspection of the Kaney Transportation, Inc facility in Rockford, Illinois

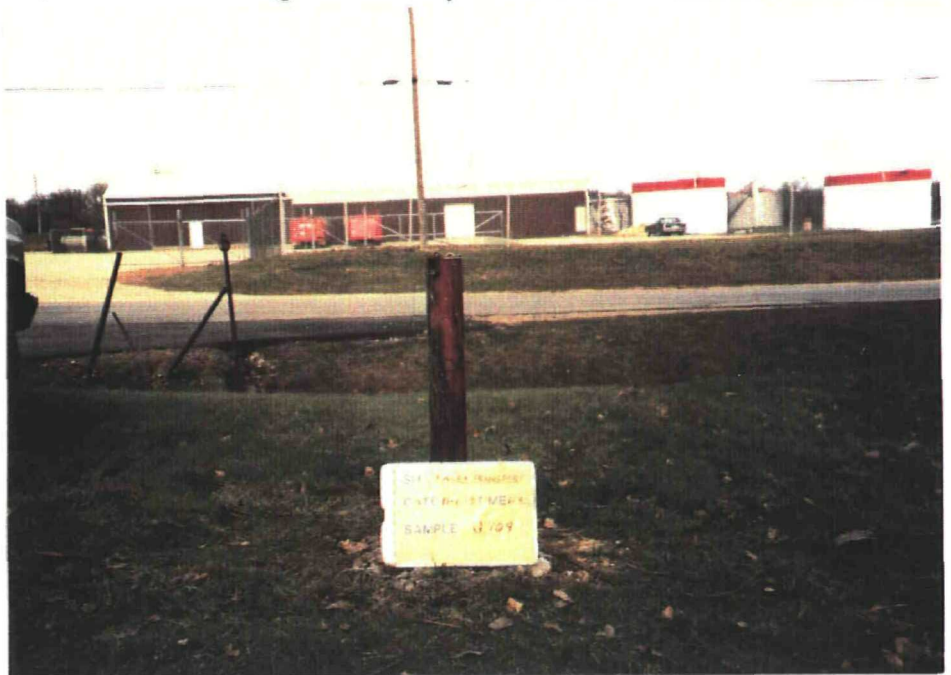
DATE: <u>11 / 6 / 91</u>	SITE #: <u>201030007</u> CO.: <u>Winnebago</u>
TIME: <u>~ 11:55A</u>	SITE NAME: <u>Kaney Transportation, Inc.</u>
PHOTOGRAPH TAKEN BY: <u>Ken Corkill</u>	
COMMENTS: Pictures taken toward: <u>the north from northeast corner of Kaney Sample G109</u>	
PHOTO #: <u>1</u>

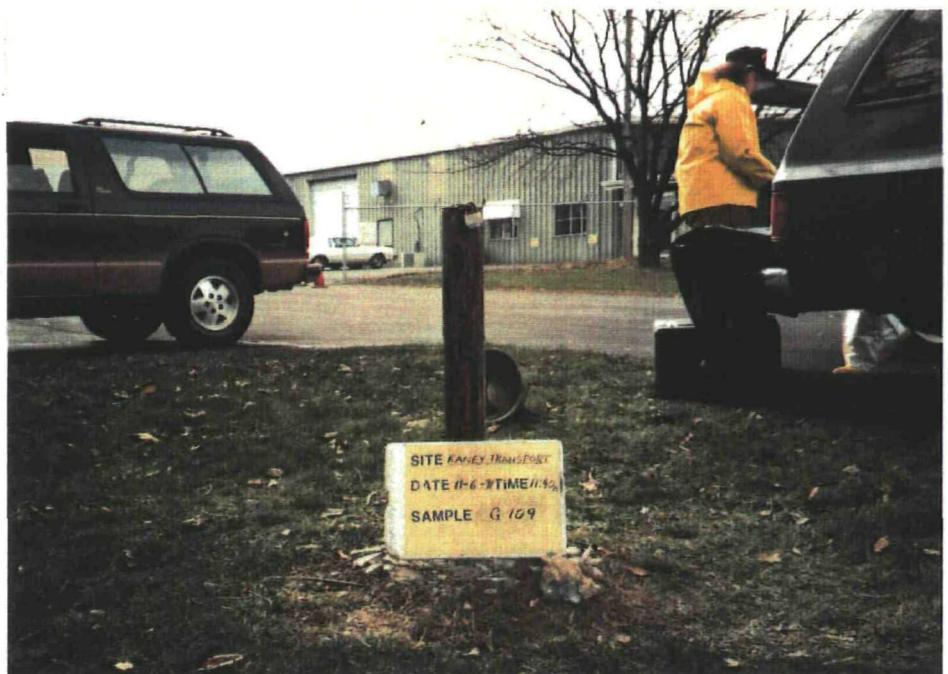
DATE: <u>11 / 6 / 91</u>
TIME: <u>~ 11:55A</u>
PHOTOGRAPH TAKEN BY: <u>Ken Corkill</u>
COMMENTS: Pictures taken toward: <u>Southwest from northeast corner of Kaney Sample G109</u>
PHOTO #: <u>2</u>

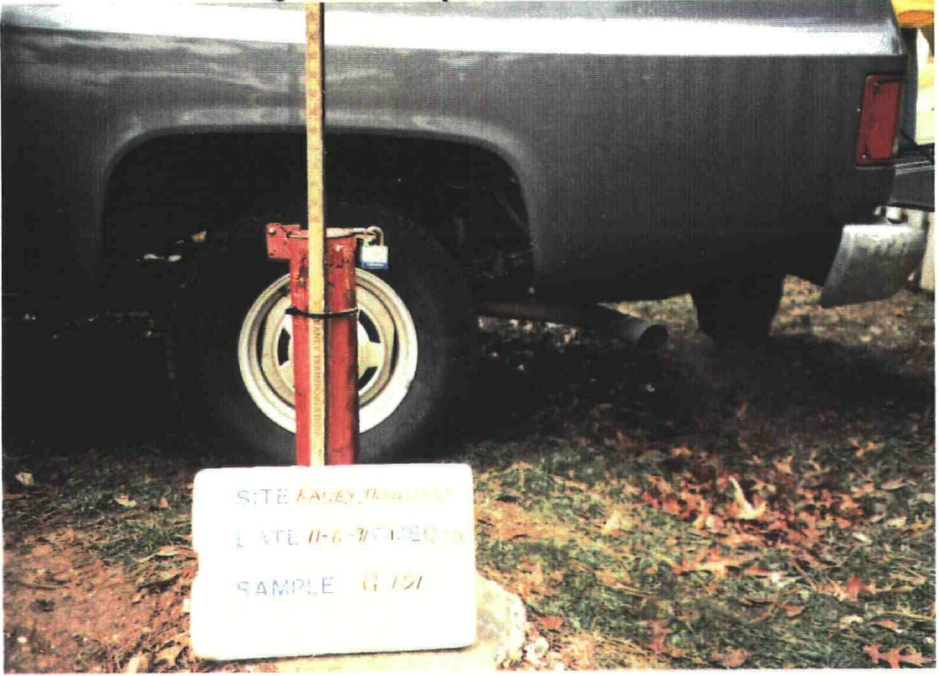
COMMENTS: Pictures taken toward: north along east property line of Kaney	
Sample G 101	
PHOTO #: 3

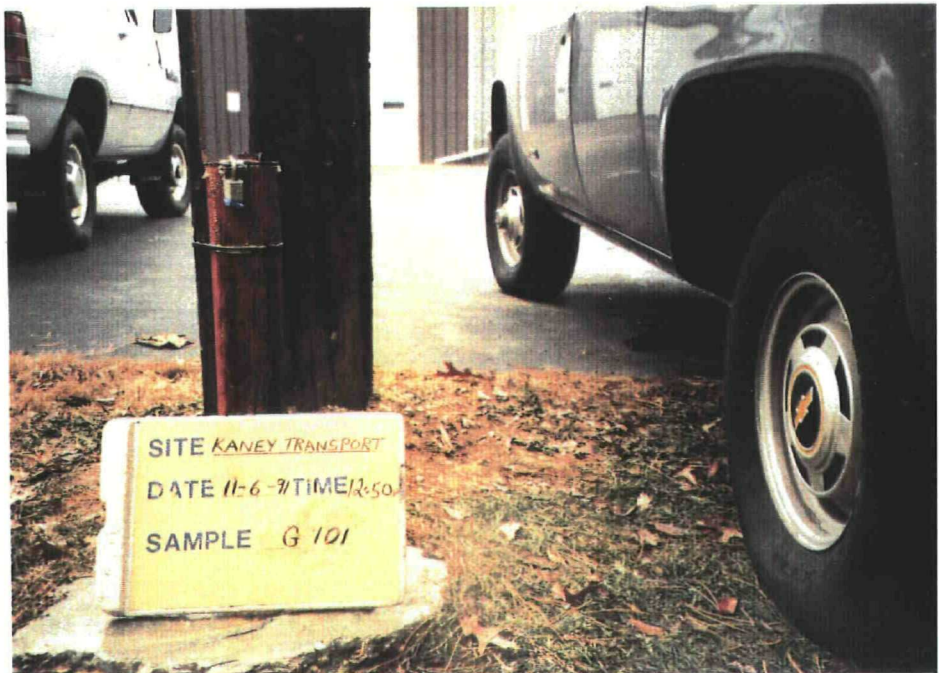
DATE: 11/6/92
TIME: ~1:05 PM
PHOTOGRAPH TAKEN BY: Ken Corkill
COMMENTS: Pictures taken toward: west along east property line of Kaney
Sample G 101
PHOTO #: 4

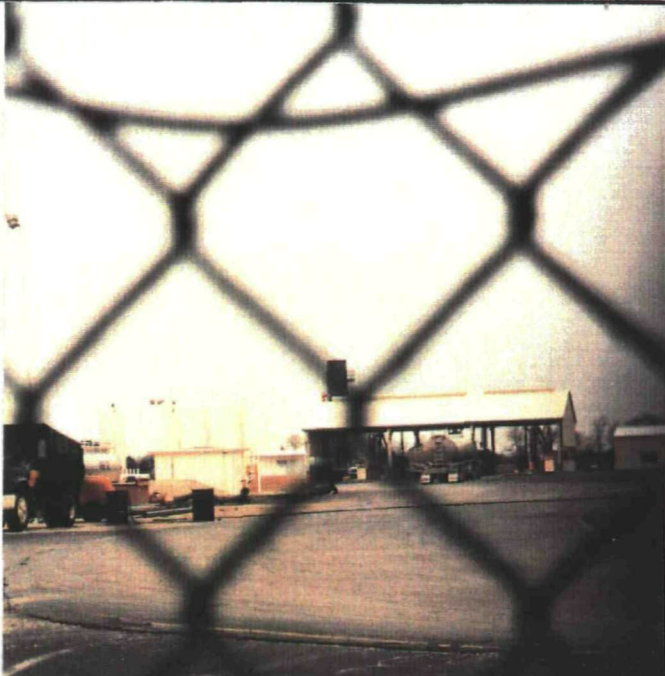
COMMENTS: Pictures taken toward: West Southwest	
toward Marathon	
Oil on northwest corner of property	
5 monitoring wells were observed in NE corner of Marathon	
PHOTO #: 5

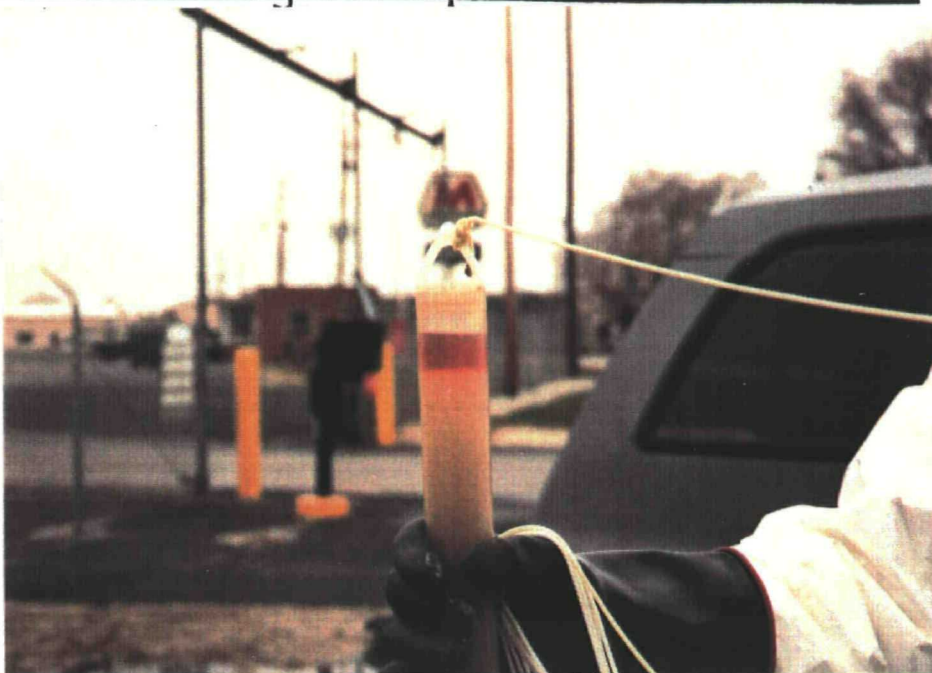
had product floating on top The HNU reading for this well registered at 300 units above background When the water was bailed out there was what appeared to be a petroleum type product floating on the surface Temperature, pH and specific conductivity readings were not administered to monitoring well G102 due to potential damage to instrumentation

DATE: 11/16/91	SITE #: 201030007 + CO.: Winnebago
TIME: ~3:45P	SITE NAME: Kaney Transportation, Inc.
PHOTOGRAPH TAKEN BY: Sheila Murphy	
COMMENTS: Pictures taken toward: west toward Marathon Oil on northwest corner of Kaney property picture of well contents bailed for G102 product floating on top PHOTO #: 7

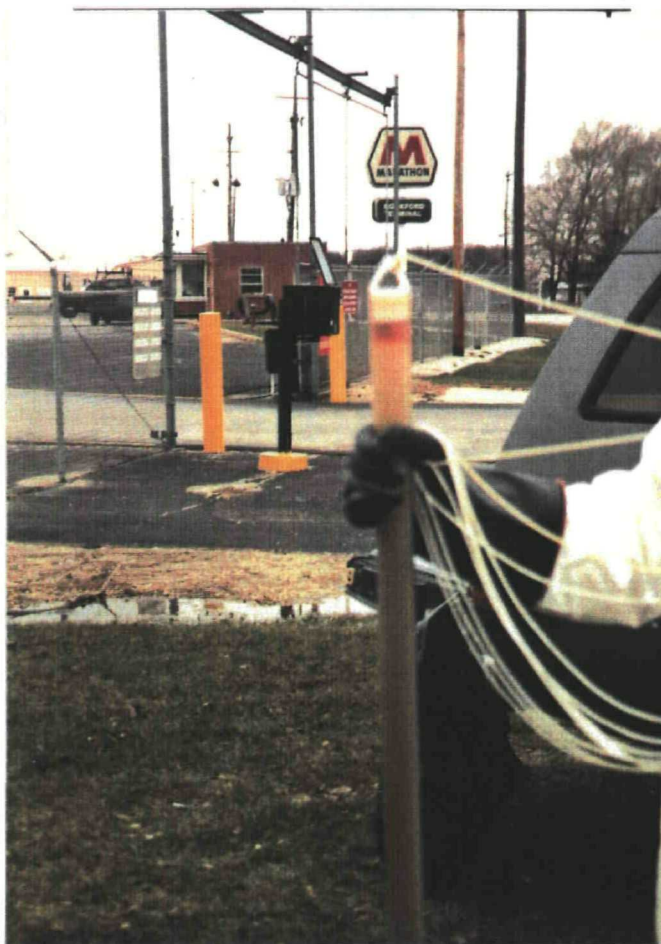
DATE: 11/16/91
TIME: ~3:45P
PHOTOGRAPH TAKEN BY: Sheila Murphy
COMMENTS: Pictures taken toward: west toward Marathon Oil on northwest corner of Kaney property picture of well contents bailed for G102 PHOTO #: 8

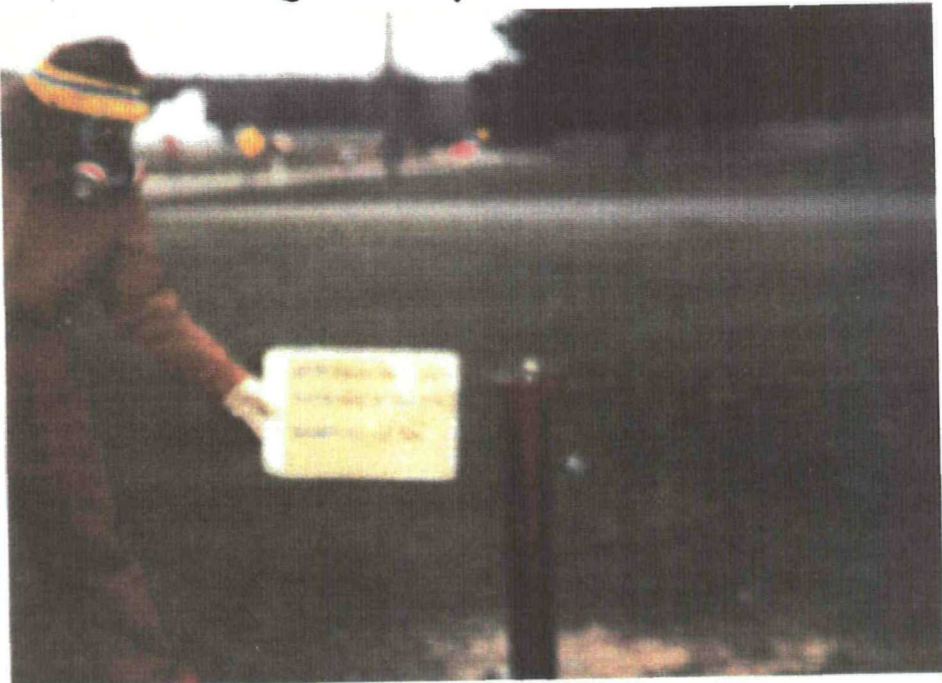
COMMENTS: Pictures taken toward: east northeast on northwest corner of Kaney property	
Sample G102	
PHOTO #: 9

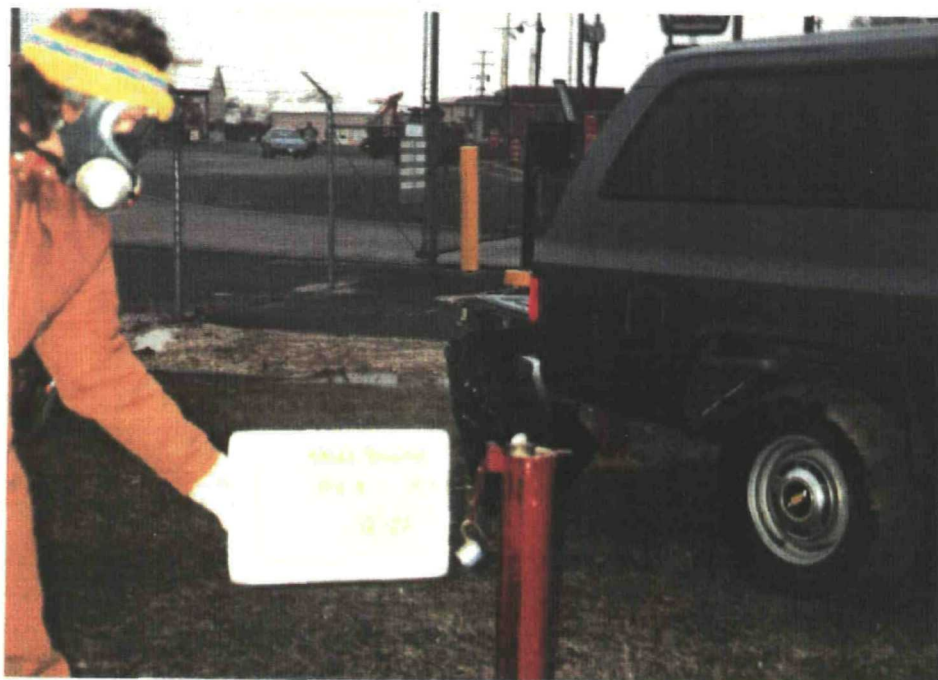
DATE: 11/6/91
TIME: ~4:15 P
PHOTOGRAPH TAKEN BY: Sheila Murphy
COMMENTS: Pictures taken toward: west southwest on northwest corner of Kaney property
Sample G102
PHOTO #: 10

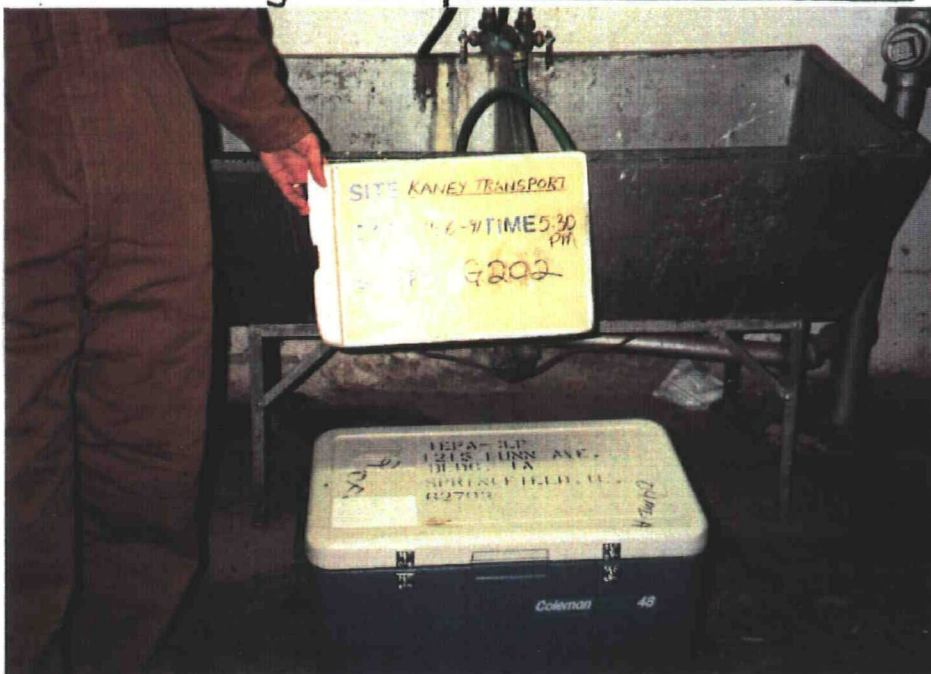
DATE: 11/14/91	SITE #: 201030001 + CO.: Winnebago
TIME: ~5:35 P	SITE NAME: Kaney Transportation, Inc.
PHOTOGRAPH TAKEN BY: Sheila Murphy	
COMMENTS: Pictures taken toward: faucet in Abels' home	
Sample G202	
PHOTO #: 11

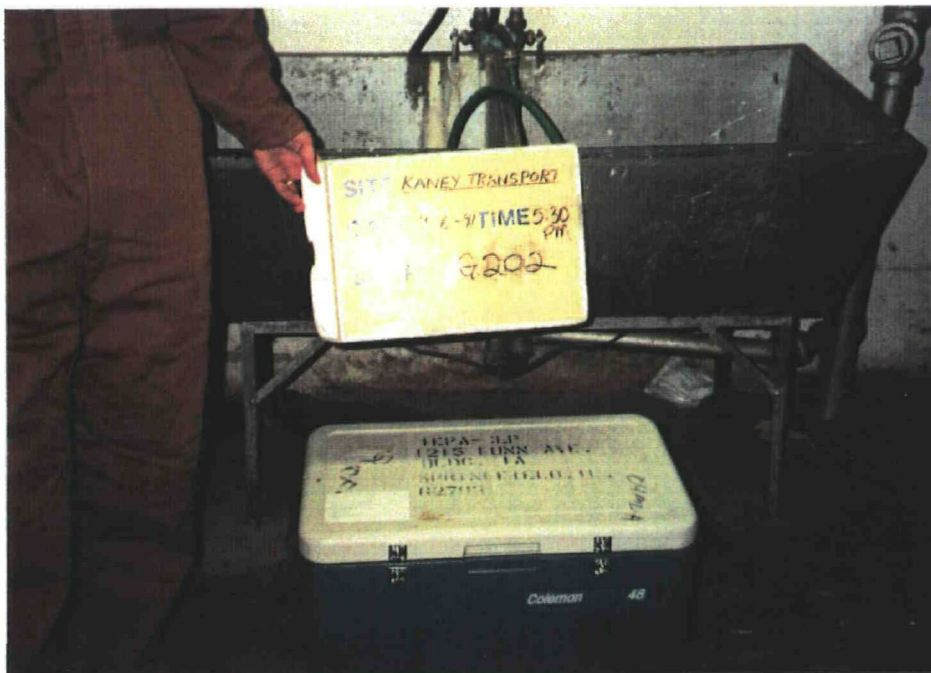
DATE: 11/14/91
TIME: ~5:35 P
PHOTOGRAPH TAKEN BY: Sheila Murphy
COMMENTS: Pictures taken toward: faucet in Abels' home
Sample G202
PHOTO #: 12

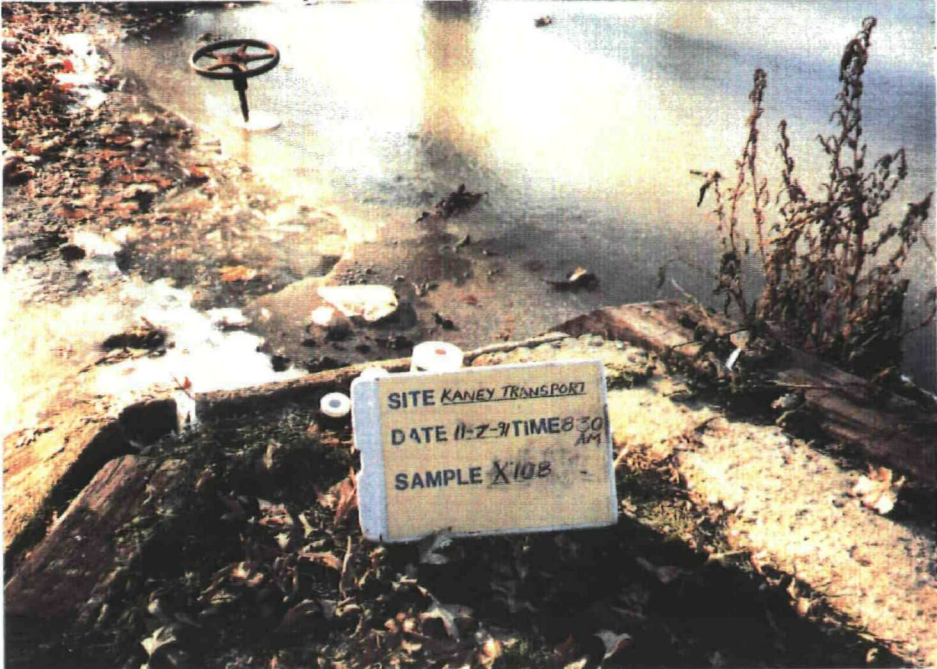
COMMENTS: Pictures taken toward: South at east end of residential pond	
Sample X108	
PHOTO #: 13

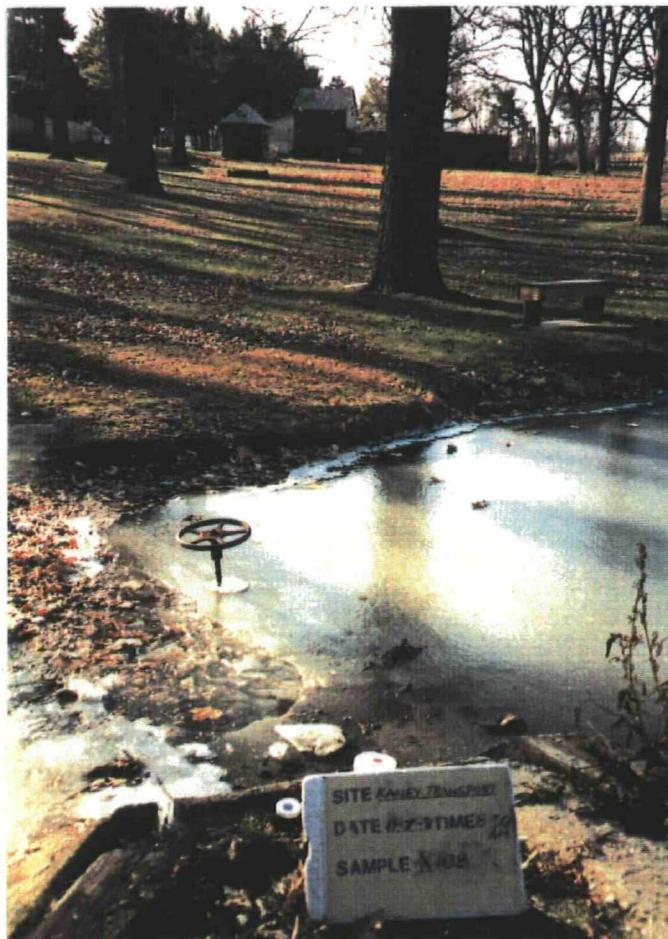
DATE: 11/7/91
TIME: ~8:35 A
PHOTOGRAPH TAKEN BY: Kim Nika
COMMENTS: Pictures taken toward: South southwest at east end of residential pond
Sample X108
PHOTO #: 14

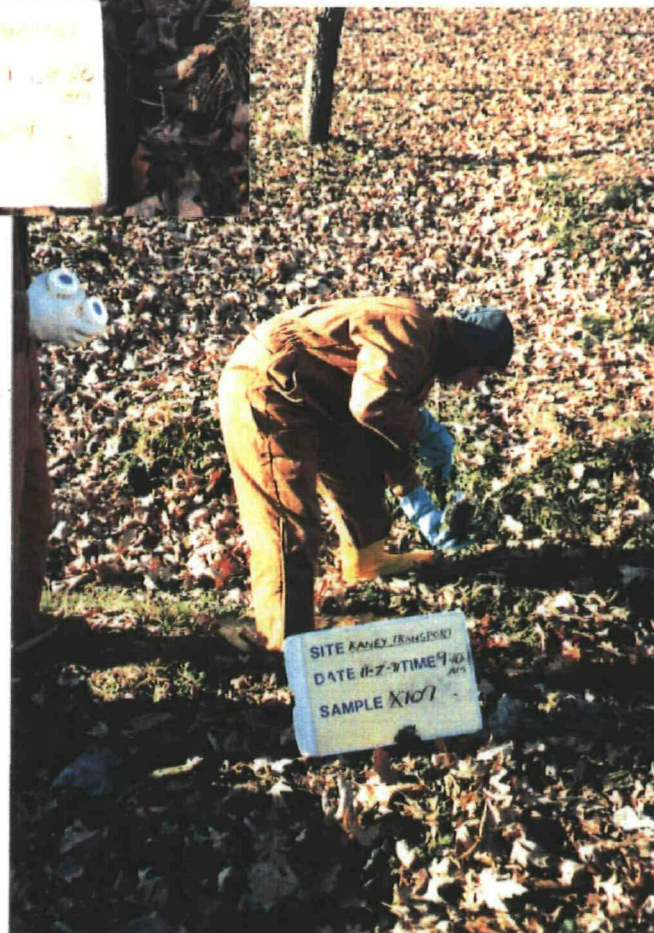
DATE: 11/7/91
TIME: 9:10A
PHOTOGRAPH TAKEN BY: Kim Nika
COMMENTS: Pictures taken toward: West at south west corner of Cunningham Rd + Meridian Rd. intersection
Sample X107
PHOTO #: 18

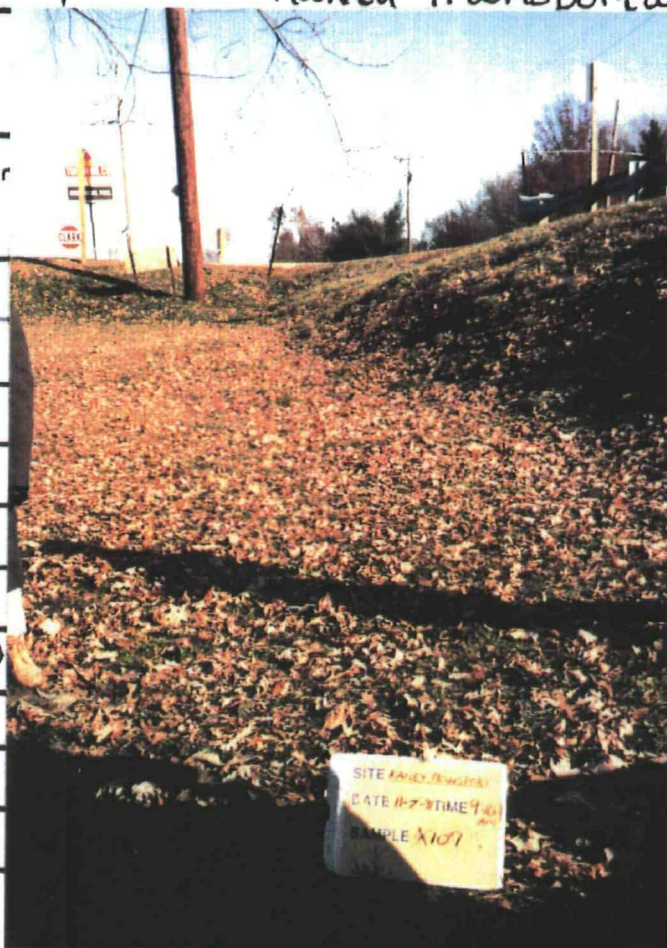
PHOTO #: 19

southwest corner of  
Cunningham Rd. +  
Meridian Rd  
intersection  
Sample X107

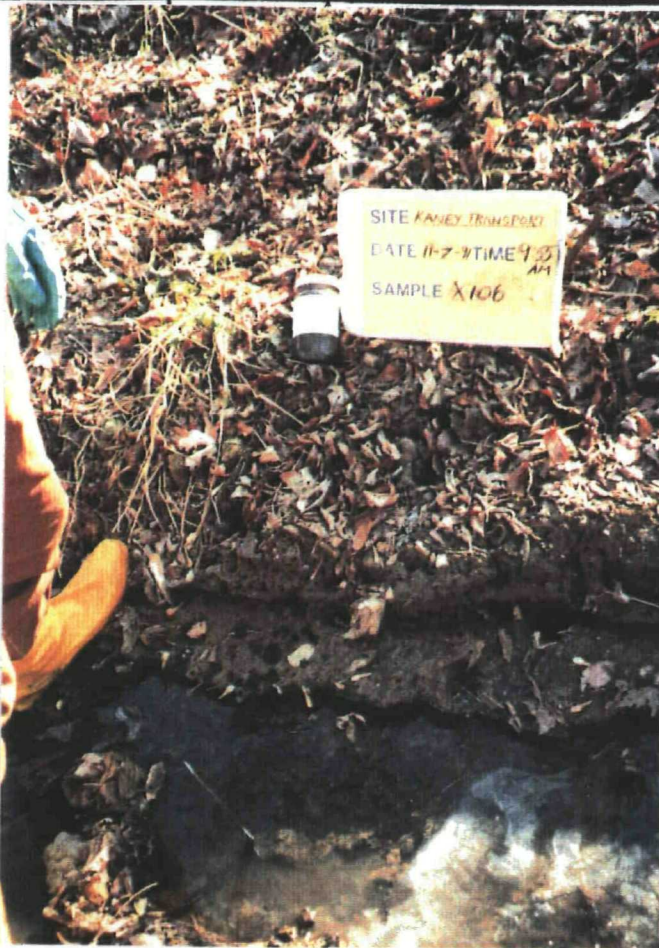
DATE: 11/7/91	SITE #: 201030001 + CO.: Winnebago
TIME: ~10:00A	SITE NAME: Kanev Transportation, Inc.
PHOTOGRAPH TAKEN BY: Kim Nika	
COMMENTS: Pictures taken toward: South 22'11"	
South of Southern boundary fence of pit +75'9" east of site east boundary fence	
Sample X106	
PHOTO #: 21

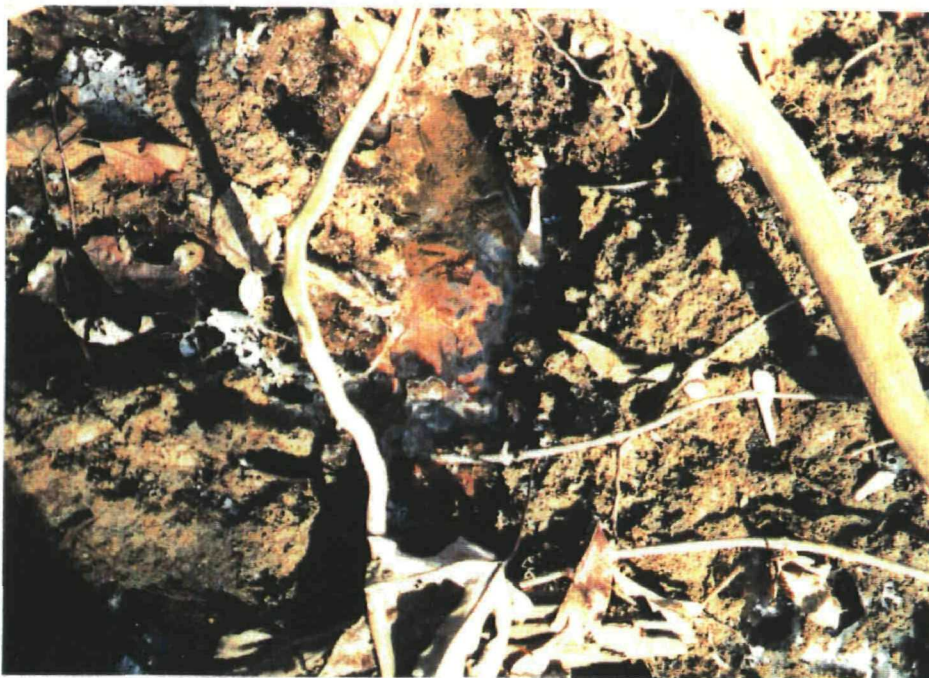
DATE: 11/7/91
TIME: 10:05A
PHOTOGRAPH TAKEN BY: Kim Nika
COMMENTS: Pictures taken toward: tank along unnamed creek where runoff was observed
PHOTO #: 22

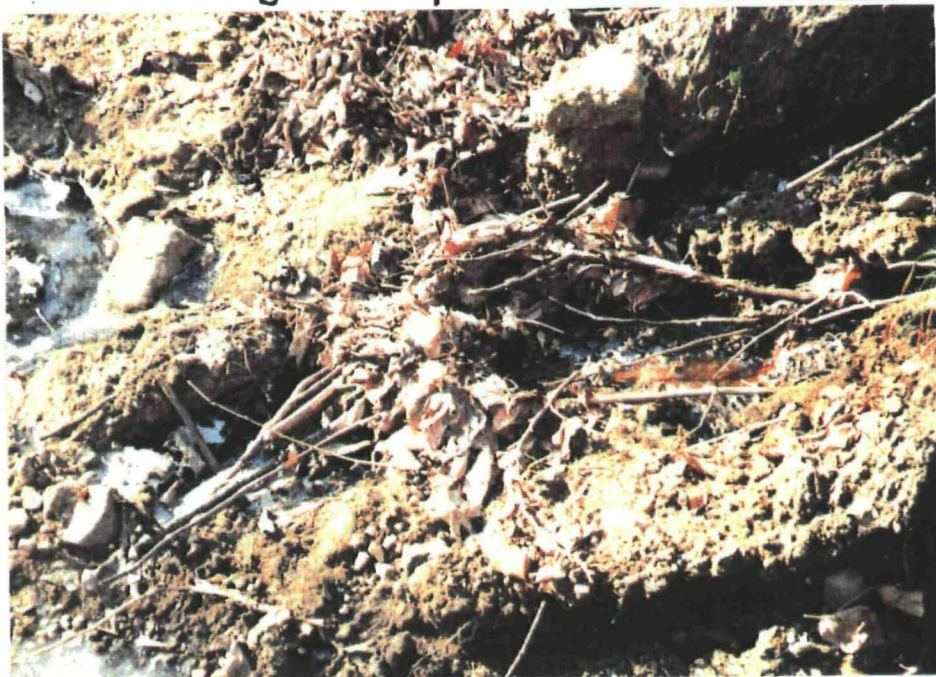
DATE: 11/7/91	SITE #: 201030001 + CO.: Winnebago
TIME: ~10:05A	SITE NAME: Kaney Transportation, Inc.
PHOTOGRAPH TAKEN BY: Kim Nika	
COMMENTS: Pictures taken toward: bank of unnamed creek, where runoff was observed.	
PHOTO #: 23

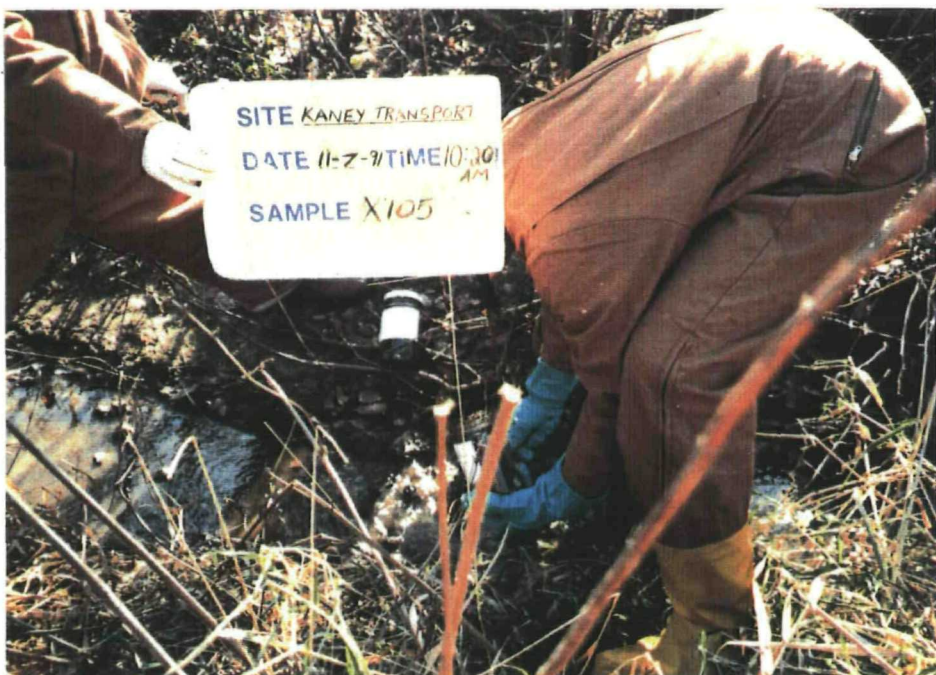
DATE: 11/7/91
TIME: ~10:25A
PHOTOGRAPH TAKEN BY: Kim Nika
COMMENTS: Pictures taken toward: east southeast along unnamed creek Sample X105
PHOTO #: 24

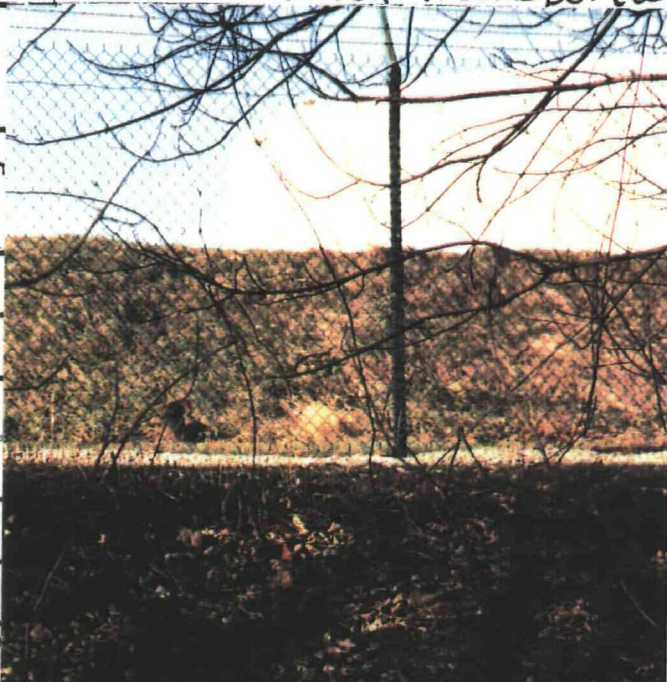
COMMENTS: Pictures taken toward: west toward Marathon Oil	
Note: low center is a pipe in the hill	
PHOTO #: 27

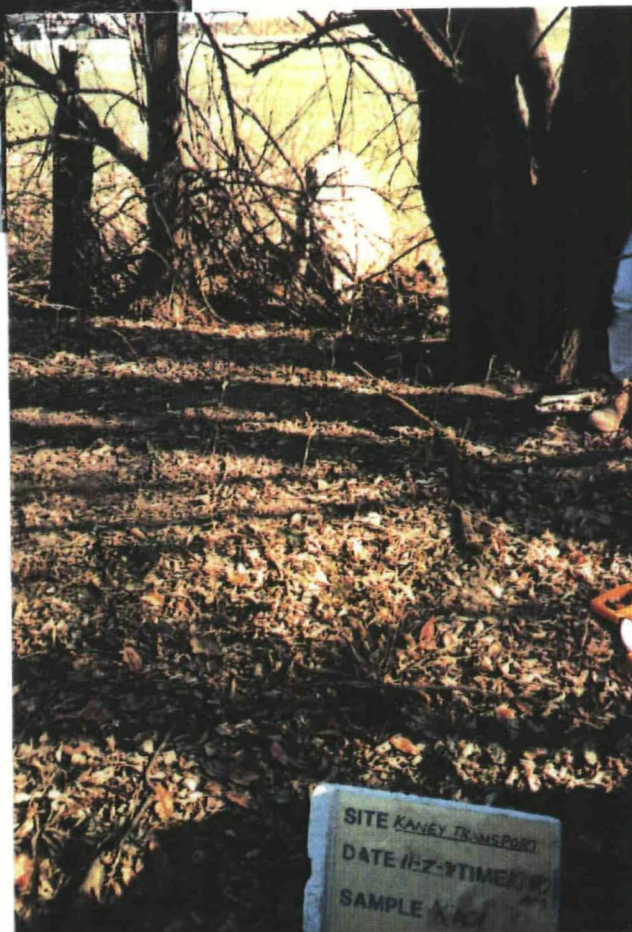
PHOTO #: 30

east along west  
side of Kaney  
property  
Sample X101

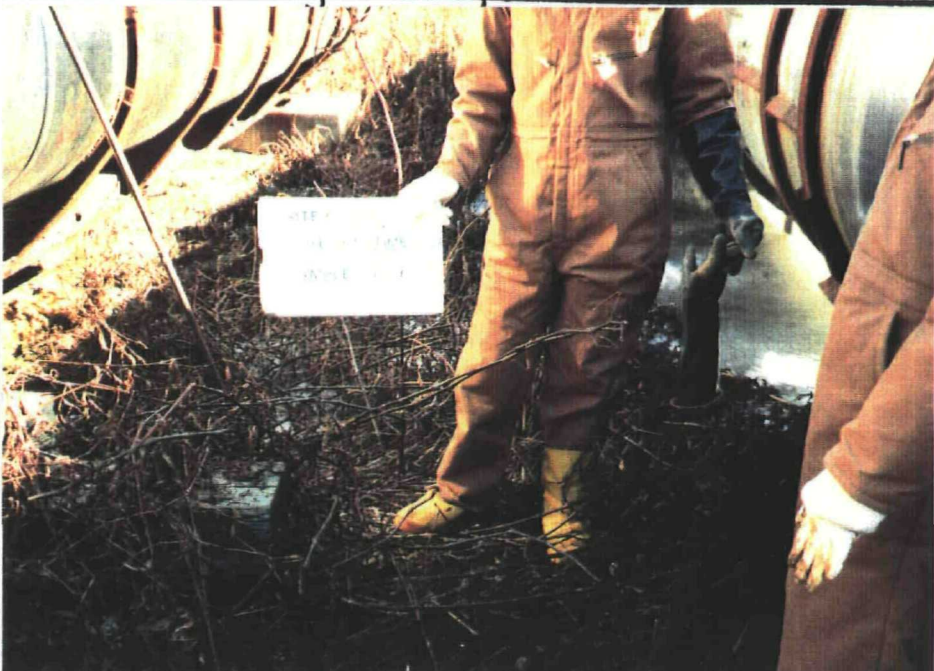
COMMENTS: Pictures taken toward: east, in lagoon	
Sample X104	
PHOTO #: 31

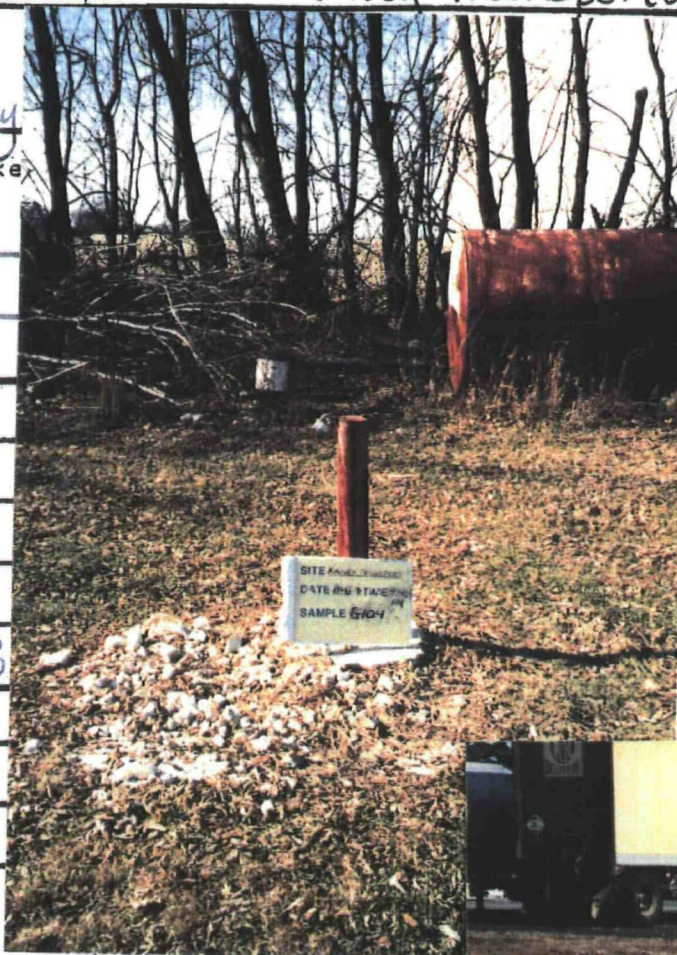
PHOTO #: 33

west side of  
Kaney property  
Sample G104

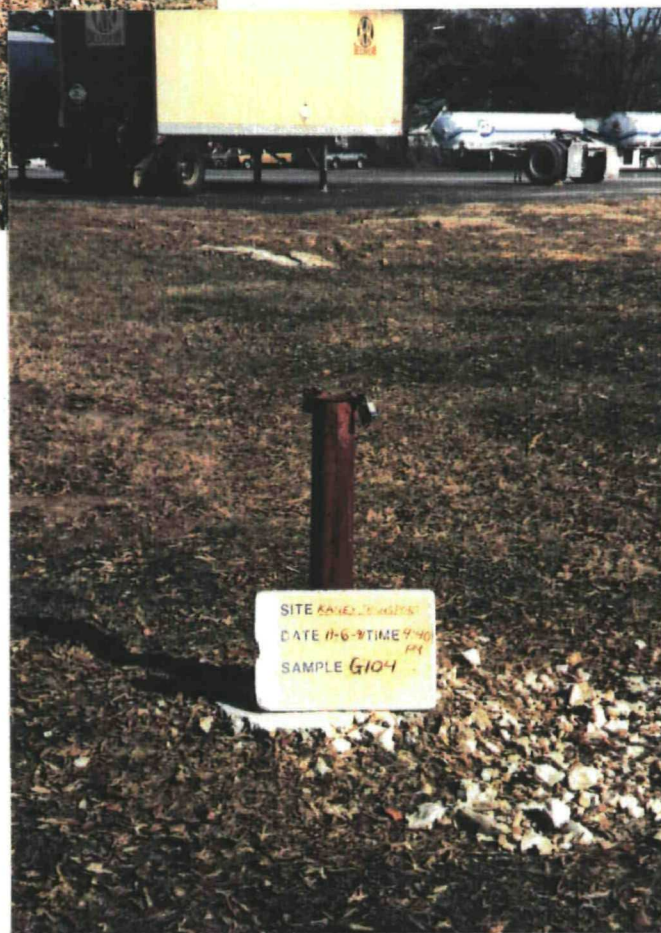
PHOTO #: 34

along west side of  
Kaney property  
Sample: G104

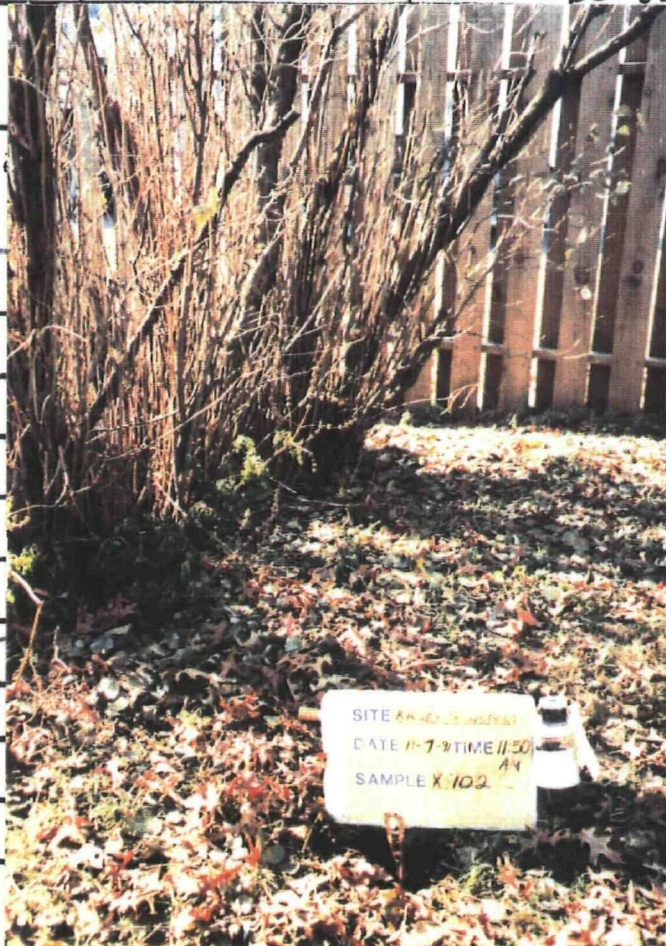
PHOTO #: 35

along Deets' west side of backyard  
Sample X102
